Burn marks at The Bull

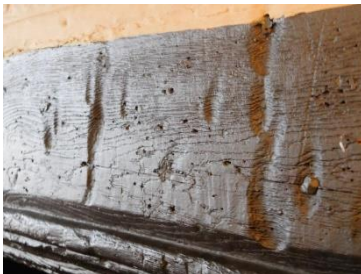
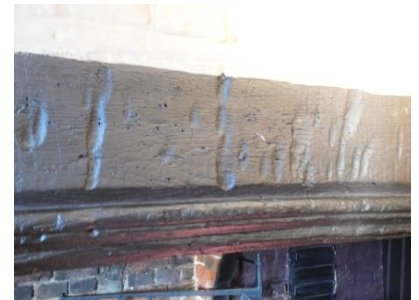
The marks in these photographs are on the mantle over the fireplace in The Bull. The mantle is part of the original 16th century timber frame of the building. Though

the beam has been stained and polished, the marks are burn marks of a kind that is relatively common in historic buildings, dating from anywhere from the late 13th to the mid-19th centuries. They are more obvious on lighter-coloured timber which has not been painted or stained, always have a characteristic tear shape, and are sometimes found with the charring still present.

James Wright and others have carried out experiments to ascertain how the marks could have been made. They found that deliberately

holding a taper, rushlight or candle at an angle of 45 degrees to the timber for at least 10 minutes produced a mark with the characteristic tear shape. This took time and patience, ruling out the possibility that the marks were made by accident.

Many burn marks such as those at The Bull are found in locations where evil spirits might enter a building, including doors and windows and particularly chimneys and hearths (including at Ye Olde Fighting Cocks in St Albans), as well as in dark spaces such as stairwells and attics. Some may have been made by practitioners of magic who would have been paid for their services.
